Manhole Inspection Summary

Manhole # S250__001MH

Insp Date: **4/3/08 10:01 AM**

Location Address: **1200 BAYARD ST.**

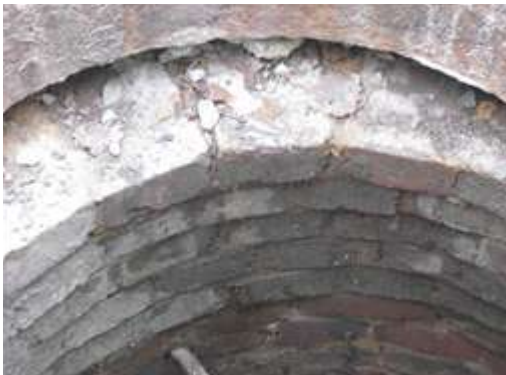
Defect 3

Infiltration: ☐ None ☐ Joint ☐ Cracks ☐ Mortar ☐ Roots ☒ **Wall**

EVIDENCE OF INFILTRATION AT THE CHIMNEY

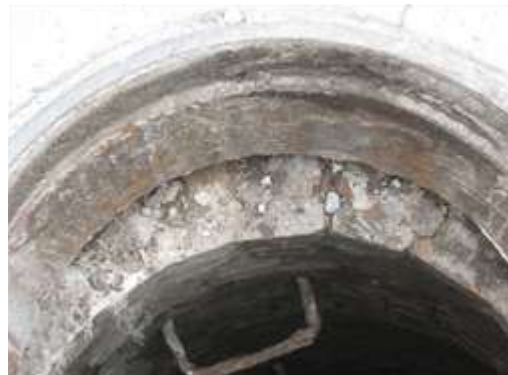
Defect 2

Frame Offset: **3.5** (in.) Condition: ☒ Sound ☐ Cracked ☐ Leaks

Steps Count: **3** Missing: **0** ☒ **Corroded**

3.5 IN FRAME OFFSET, STEPS CORRODED

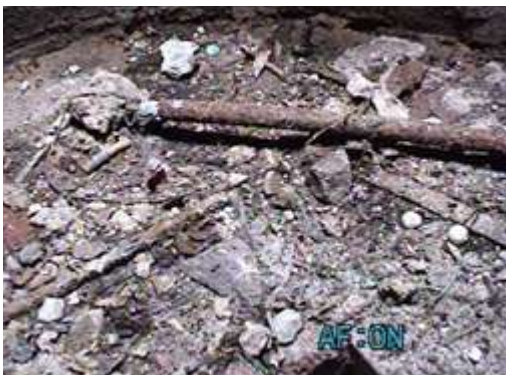
Defect 1

Condition: ☐ Sound ☐ Cracked ☐ Root Intrusion ☐ Deteriorated ☐ Leaks ☒ **Debris**

DEBRIS ON THE BENCH
